HAZUS User Group
Success Story

Eagle, Alaska Uses HAZUS

to Map Safe Rebuilding Zones Following Ice Jam Devastation

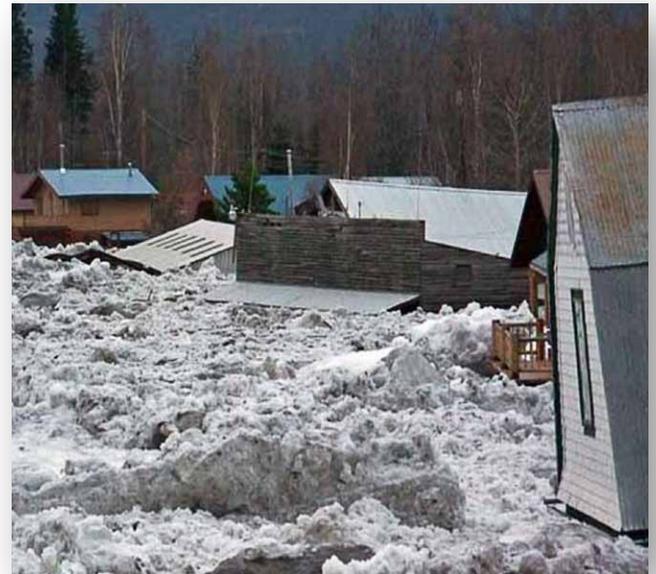
Ice and debris flowing through Eagle, Alaska.

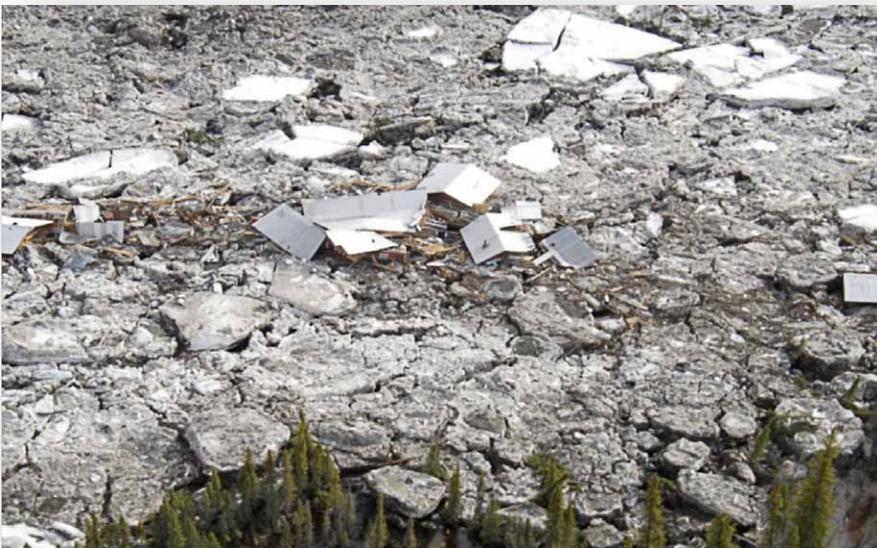
Aerial view of devastation in Eagle, Alaska.
